NATIONAL PROGRAM FOR INSPECTION OF NON-FEDERAL DAMS
WOODS POND (VALLEY MI.) (U) CORPS OF ENGINEERS WALTHAM
MA NEW ENGLAND DIV JUL 79

MA-00731

July 1979

DAM: WOODS POND (VALLEY MILL)
IDENTIFICATION NO. MA 00731

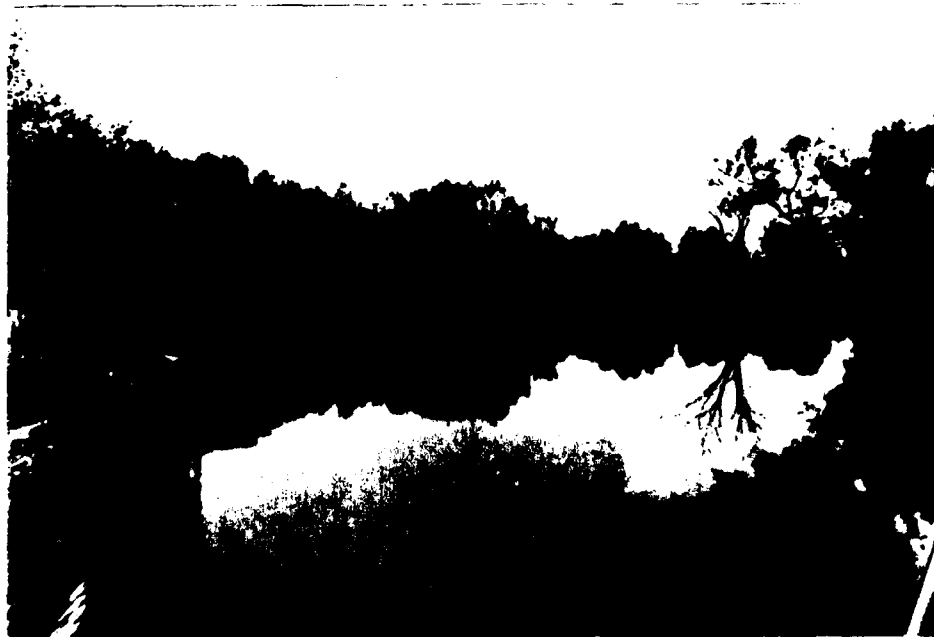
3. Right bank of reservoir area immediately upstream of dam
